DOT/FAA/SA-88/2

In-Service Evaluation of the Traffic Alert and Collision Avoidance System (TCAS) Industry Prototype

Daniel H. Tillotson
Loren D. Bolstridge
Gary P. Gambarani

May 1988

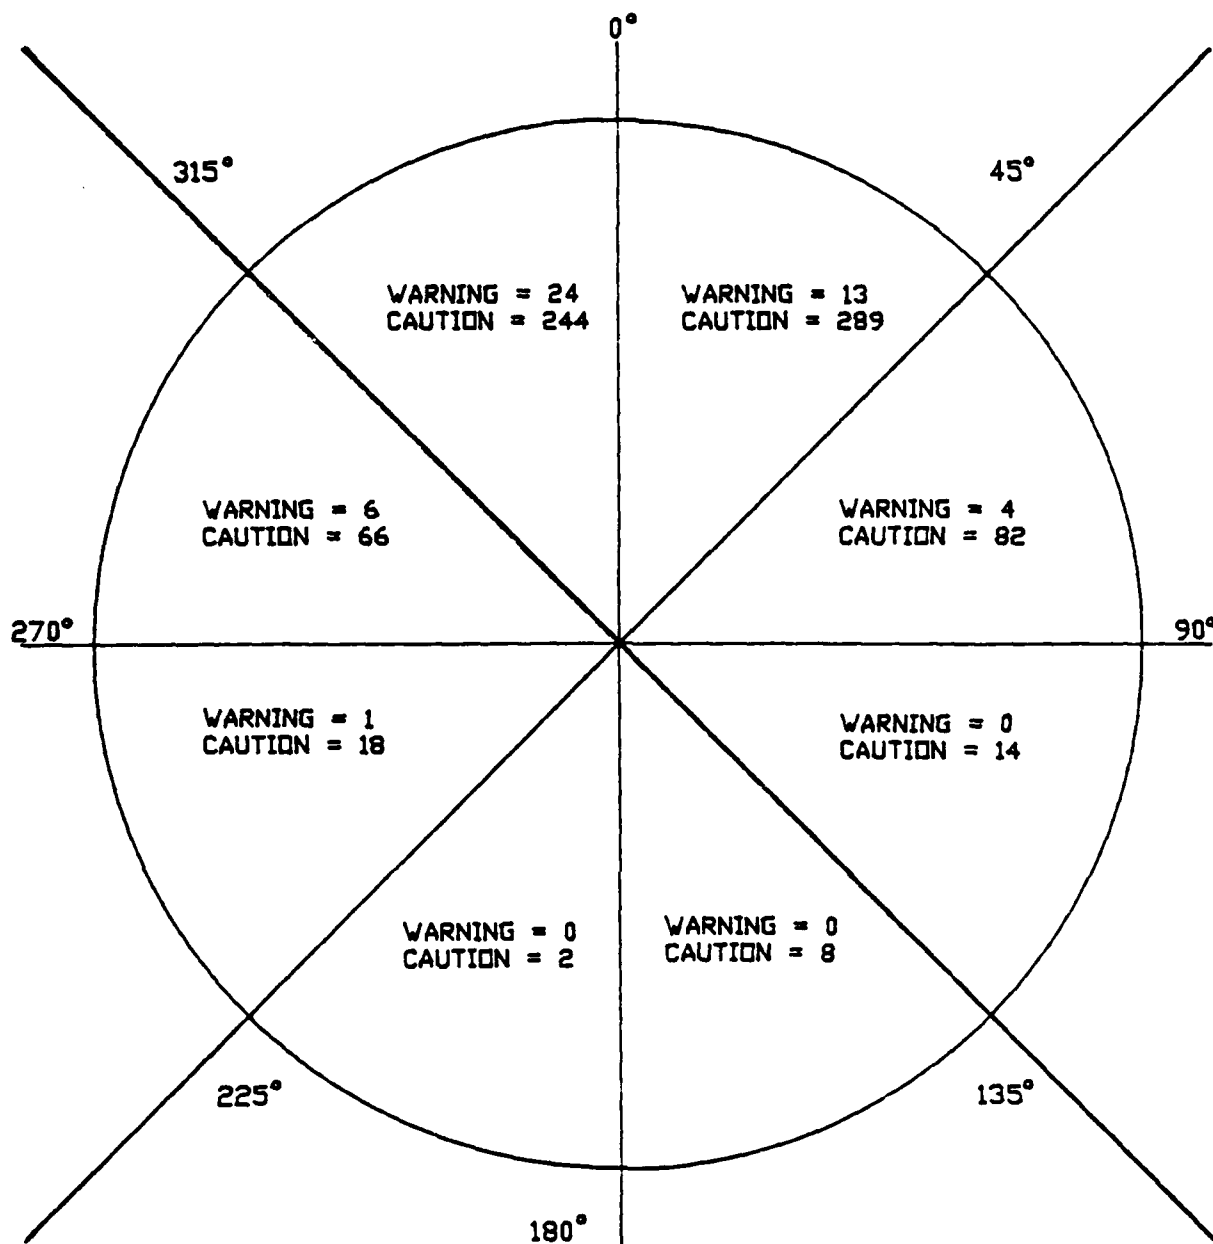
FIGURE S-1

ADVISORIES BY INITIAL BEARING (ALL INTRUDERS)

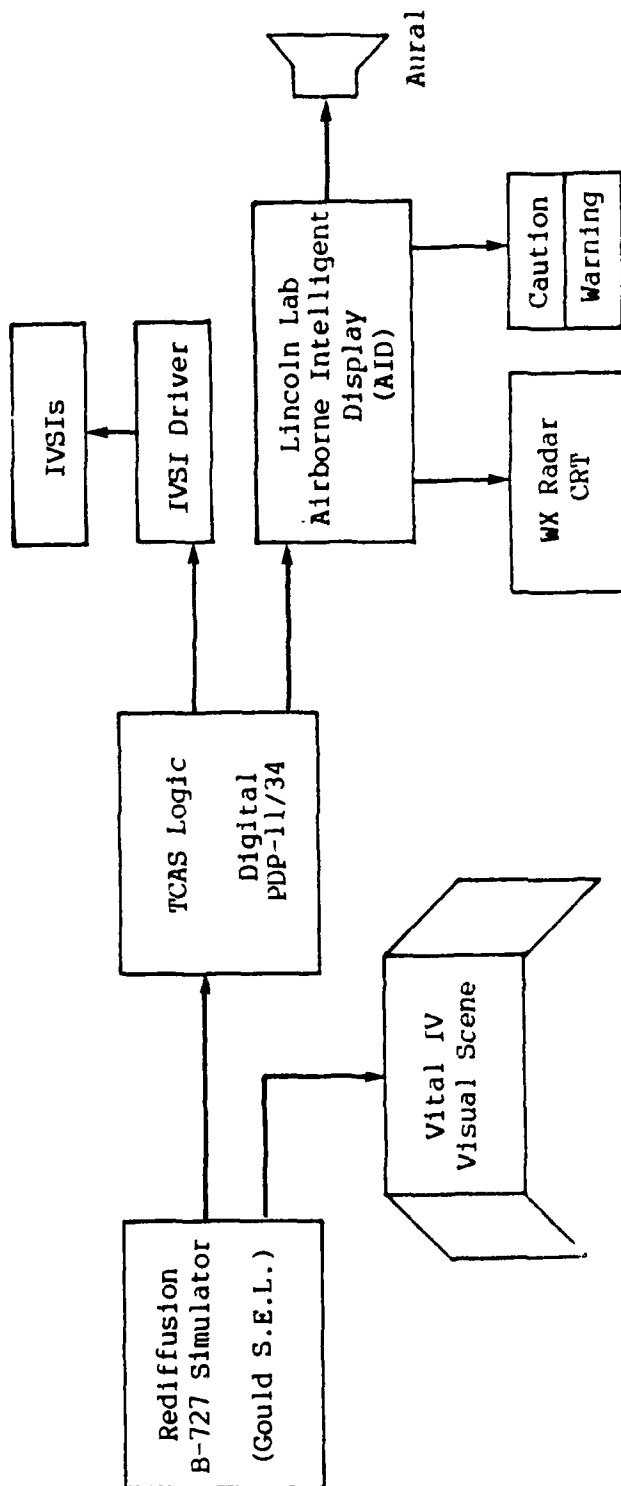
FIGURE 2-6
PIEDMONT AIRLINES' TCAS SIMULATION CONFIGURATION

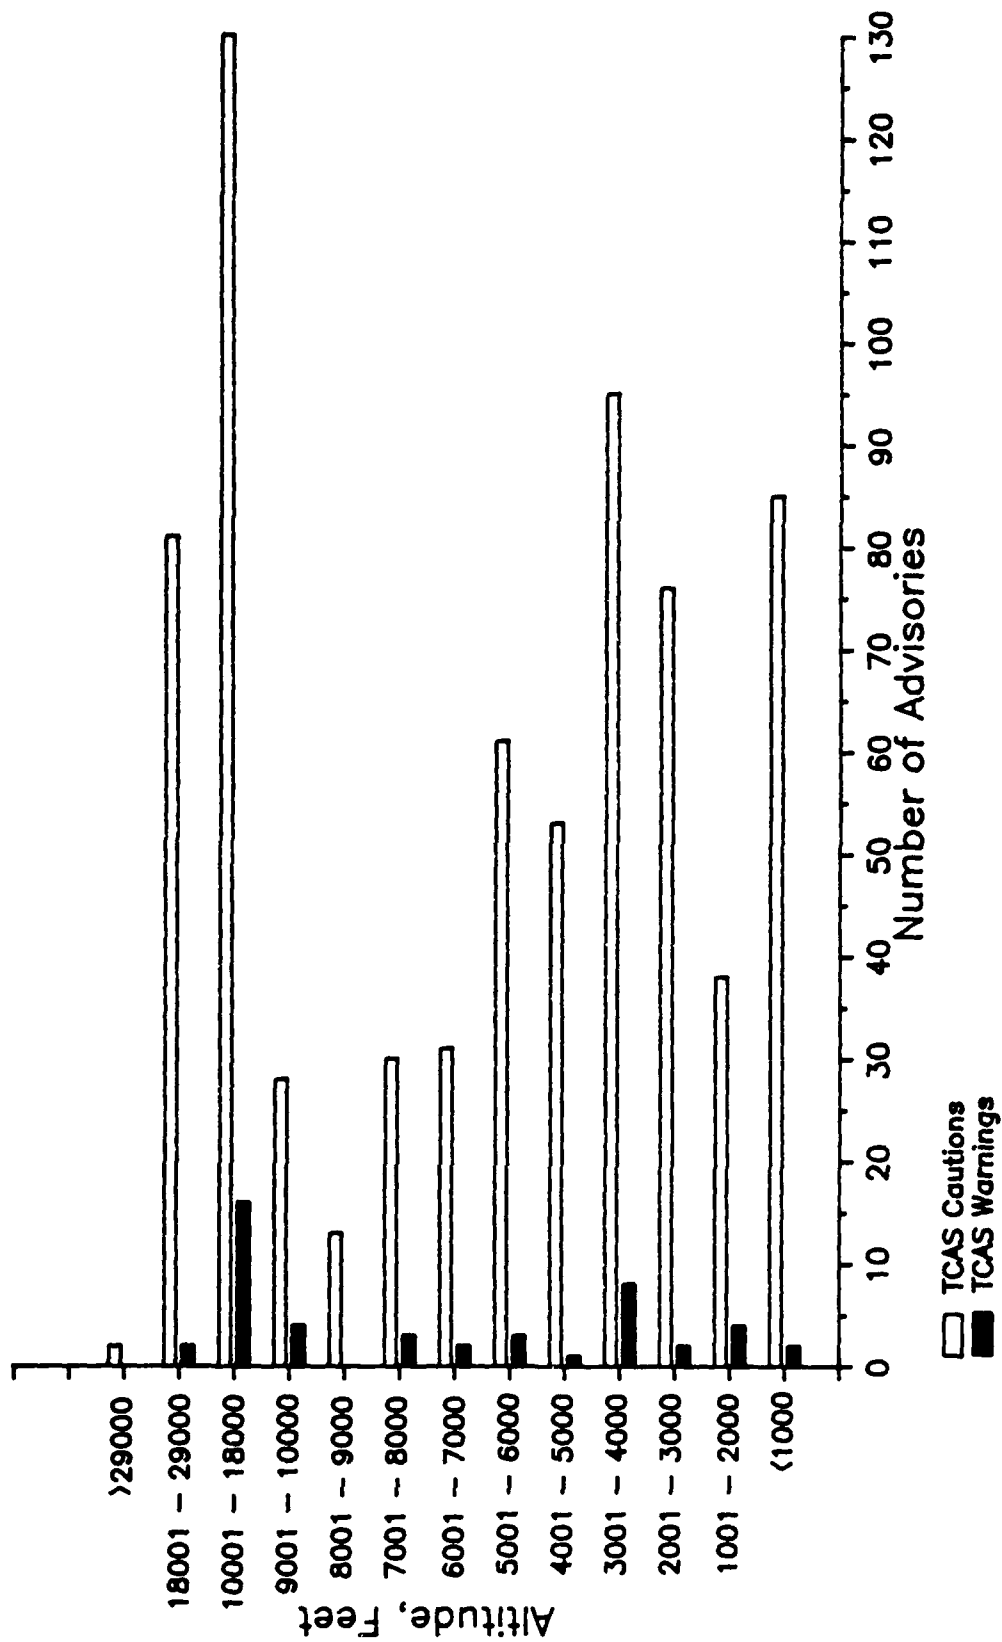
FIGURE 4-2
 OWN ALTITUDE WHEN ADVISORY IS ISSUED

The distribution shown in Figure 4-2 indicates that 85 TCAS Cautions occurred while the TCAS aircraft was operating below 1,000 feet MSL.

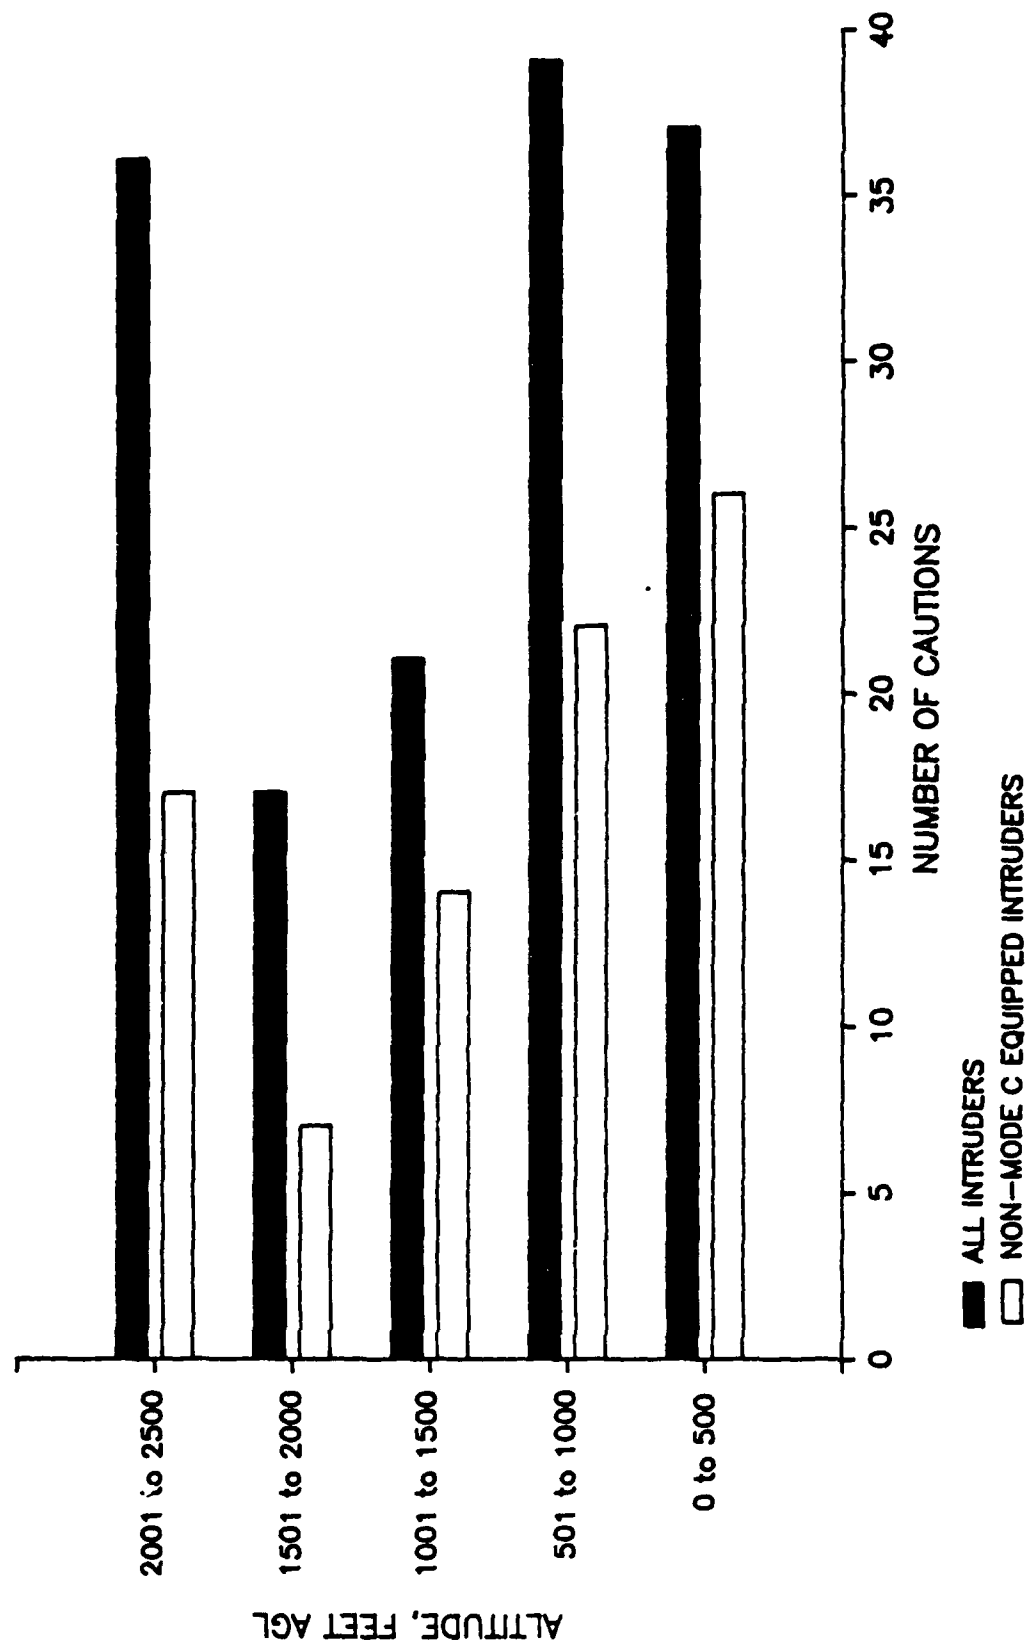
FIGURE 4-3

TCAS AIRCRAFT ALTITUDE WHEN CAUTION IS ISSUED

After the Phase I evaluation, logic was added to prevent the display of aircraft on the ground. This modification was proven to be effective against aircraft equipped with altitude reporting transponders. However, non-altitude reporting aircraft do not provide sufficient inputs into the TCAS logic to enable TCAS to declare that an aircraft is on the ground. As a result, TCAS will issue a TCAS Caution against non-altitude reporting aircraft whose transponders are turned on while they are taxiing. (This problem is discussed in detail in Section 6.2.) Figure 4-3 shows the distribution of own-aircraft altitude when non-Mode C and Mode C TCAS Cautions are issued. Since the TCAS Aircraft-On-Ground logic operates only when the TCAS aircraft is below 2,500 feet AGL, Figure 4-3 shows the altitude distribution from zero to 2,500 feet.

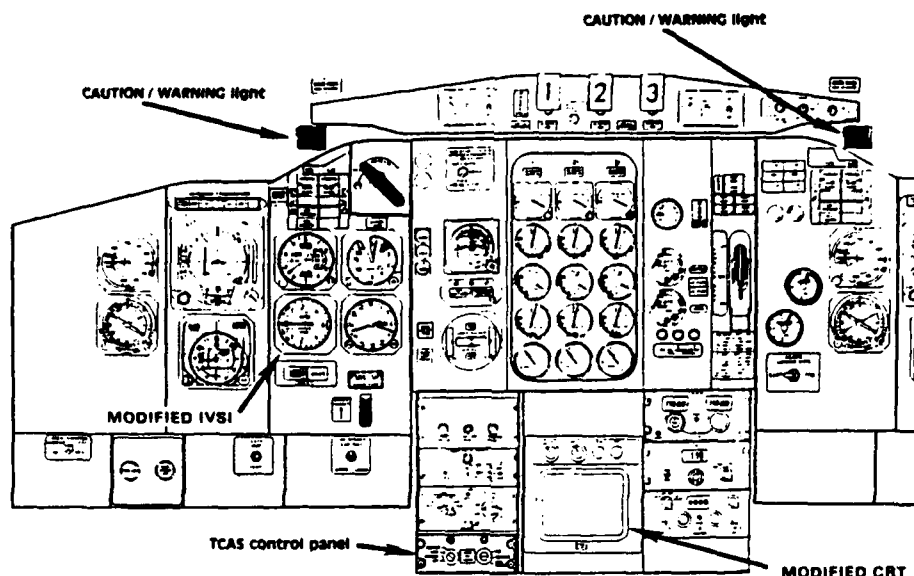
FIGURE 4-18

LOCATION OF TCAS COCKPIT EQUIPMENT

The crews and observers were also critical of the inability to control the brightness of the Caution/Warning lights. The lighting intensity was observed to be satisfactory for all daytime operations, including direct sunlight. However, at night the lights were much too bright, and the crews felt "blinded" by their intensity. This problem can be resolved by wiring the Caution/Warning lights into the aircraft's Master Warning Test and Dim switch. This is preferable to having a

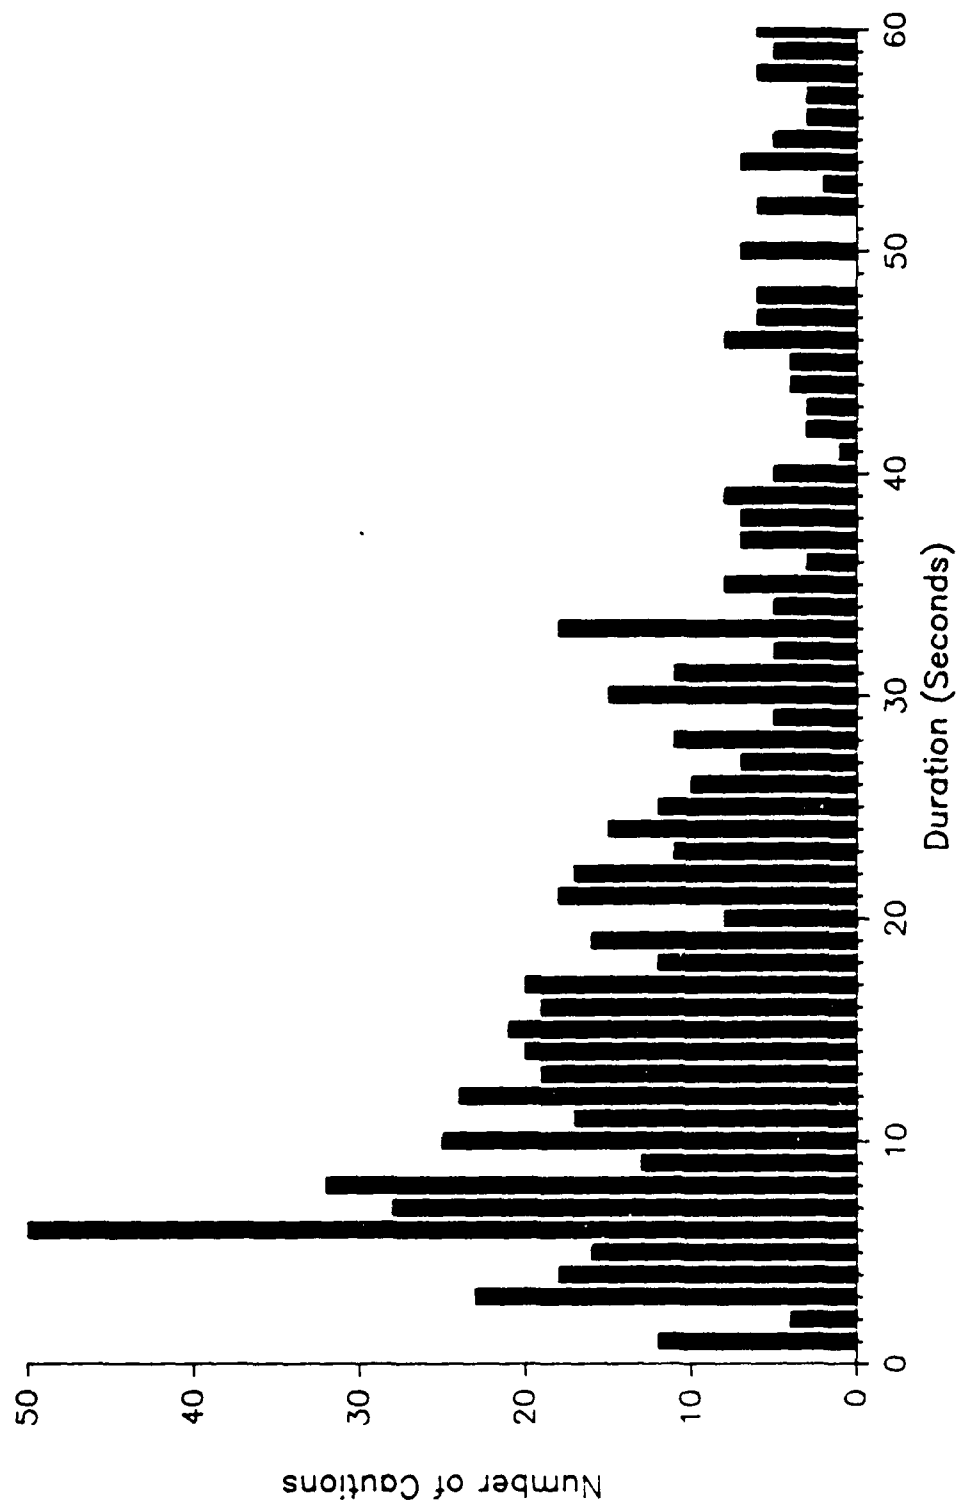
FIGURE 6-1
DISTRIBUTION OF TCAS CAUTION DURATION (ALL CAUTIONS)

Numerous encounters were observed in which a Caution was displayed for a very short period. As shown in Figure 6-1, 65 Cautions (9 percent) are displayed for less than five seconds and 159 (22 percent) are displayed for less than eight seconds. These short duration displays are a nuisance and distraction to the flight crews and may diminish confidence in the system. The major problem with having Cautions displayed for a short period is that the crews do not have sufficient time to recognize that a Caution is being displayed and interpret the

data before the display is cleared. By the time the aural annunciations are completed and the crew looks at the display to determine the location of the intruder, the display is blanked.

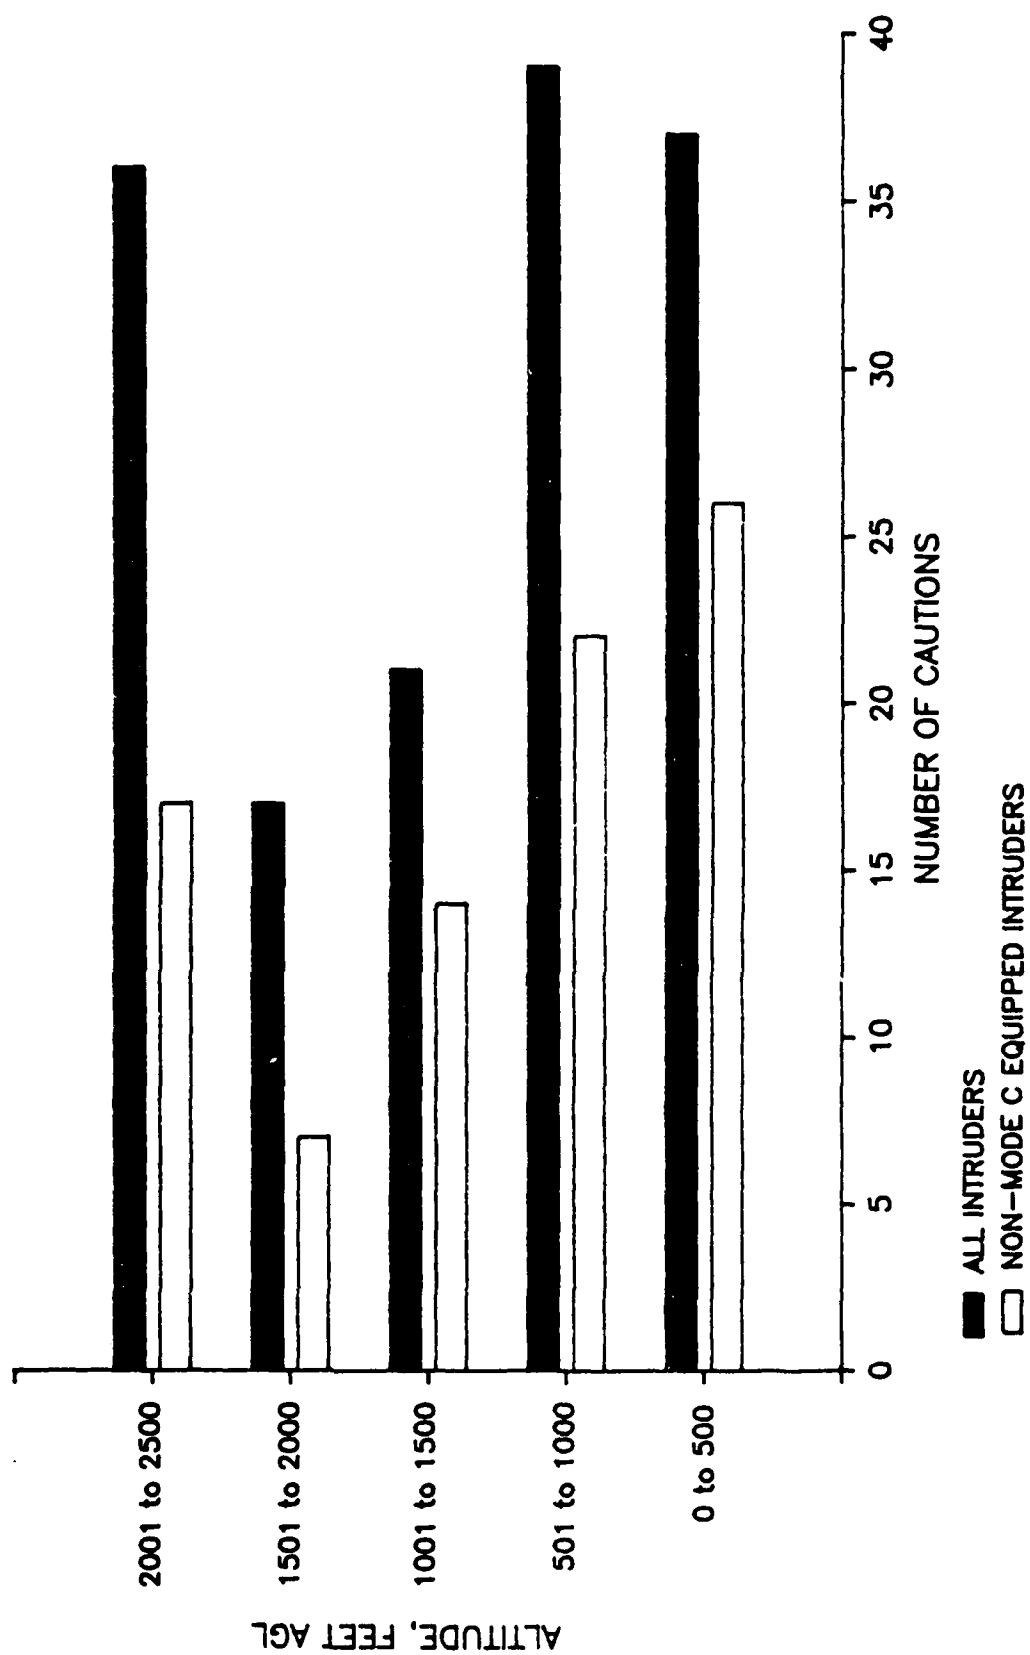
FIGURE 6-3
TCAS AIRCRAFT ALTITUDE WHEN CAUTION IS ISSUED

equipped aircraft, the intruder aircraft was determined to be an aircraft taxiing near the departure runway. Without an altitude reporting transponder, there is no way for TCAS to determine if the intruder is on the ground or in the air.

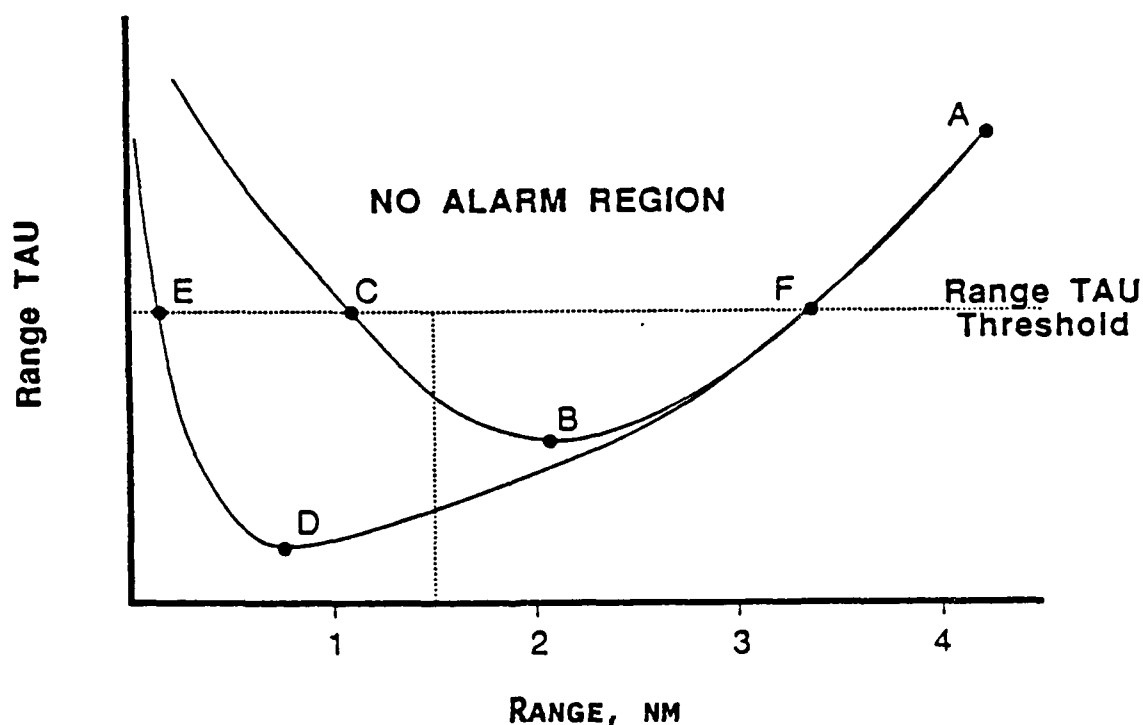
FIGURE 6-4
RANGE VERSUS RANGE TAU FOR NUISANCE ALARM FILTER

To eliminate these types of advisories, MITRE has designed a Nuisance Alarm Filter for the TCAS II logic. It will prevent the TCAS logic from issuing a Warning against threats whose range tau (TRTRU) has begun to rise and whose range exceeds 1.5 nautical miles. The operation of the filter is illustrated in Figure 6-4, which shows true range tau (TRTRU) versus range. As an intruder aircraft converges with the TCAS aircraft, the value of TRTRU decreases. When this value drops below the range tau threshold, it is said to have satisfied the range criterion for issuance of a Warning. At any time thereafter, if the vertical separation of the two aircraft falls below the altitude threshold (ZTHR), a Warning will be issued.

The curve AFBC in Figure 6-4 is representative of an encounter with an intruder aircraft whose range tau begins to rise when it is separated from the TCAS aircraft by 2 miles. This encounter situation will result in a Warning if the altitude criterion is satisfied any time after the curve crosses the range tau threshold (at point F). However, if the altitude criterion is satisfied at point B or later, the relative bearing

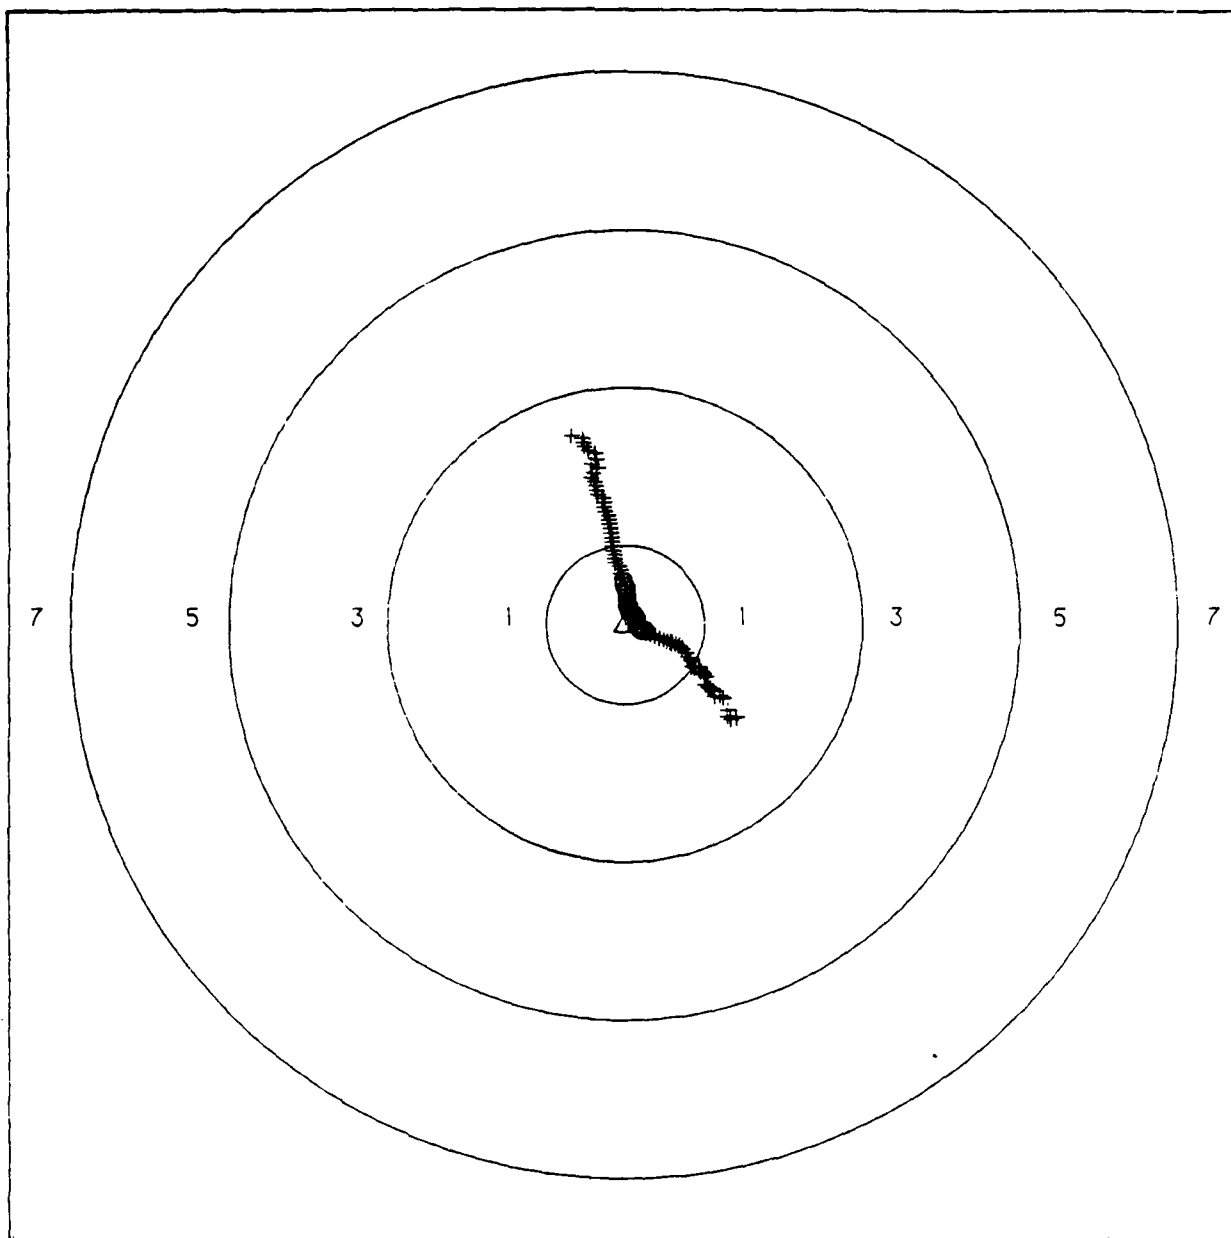
FIGURE D-7
TCAS WARNING 4: BEARING PLOT

The recorded data for this encounter are shown in Figures D-7 and D-8.

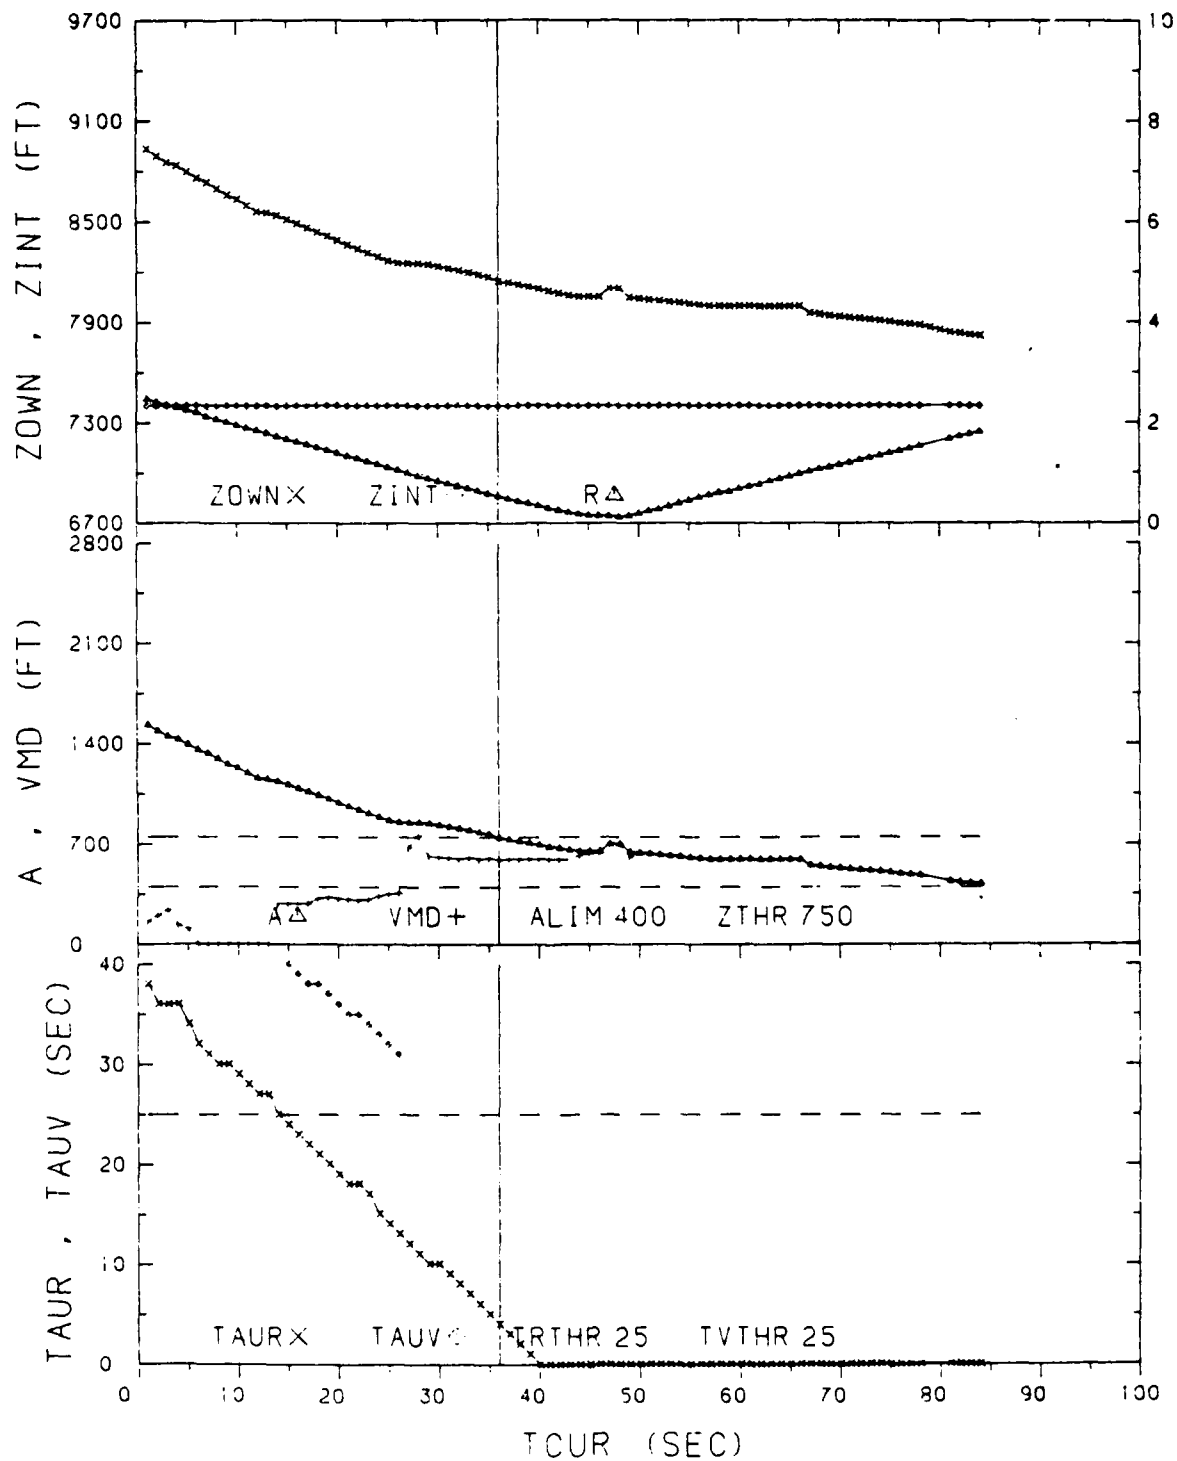
FIGURE D-8

TCAS WARNING 4: PARAMETERS

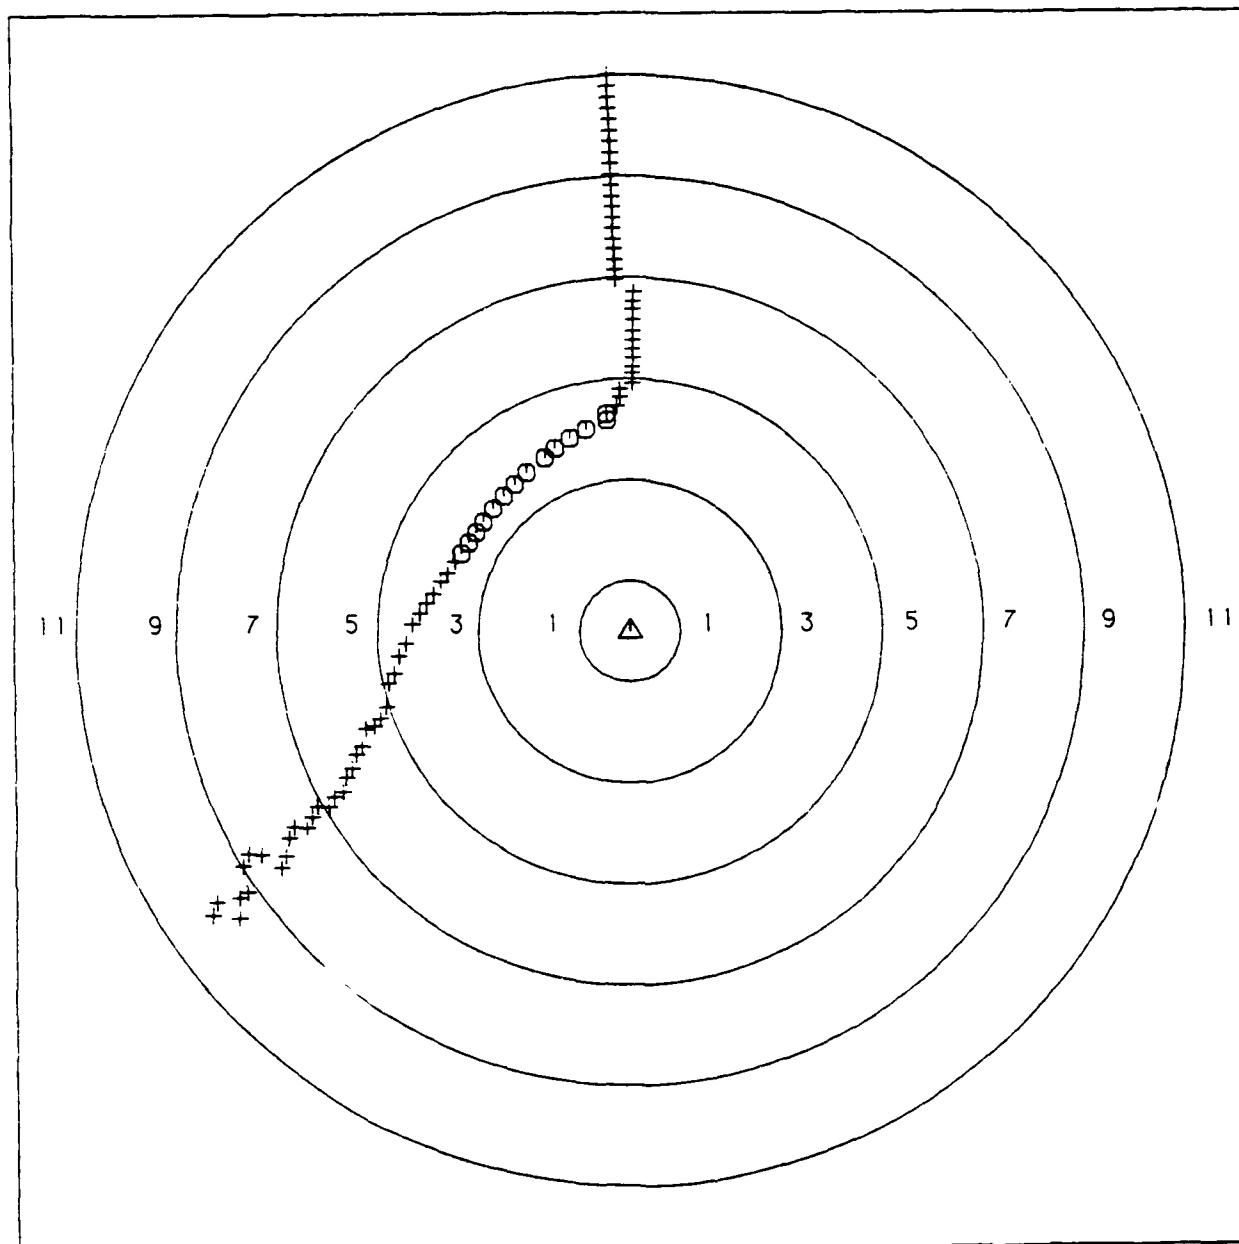
FIGURE D-25

TCAS WARNING 19: BEARING PLOT

Warning 19 was not witnessed by a TCAS observer. The recorded data for this encounter are shown in Figures D-25 and D-26. This encounter occurred on June 23, 1987, while the TCAS aircraft was operating on Flight 66 between Orlando, Florida, and Baltimore, Maryland.

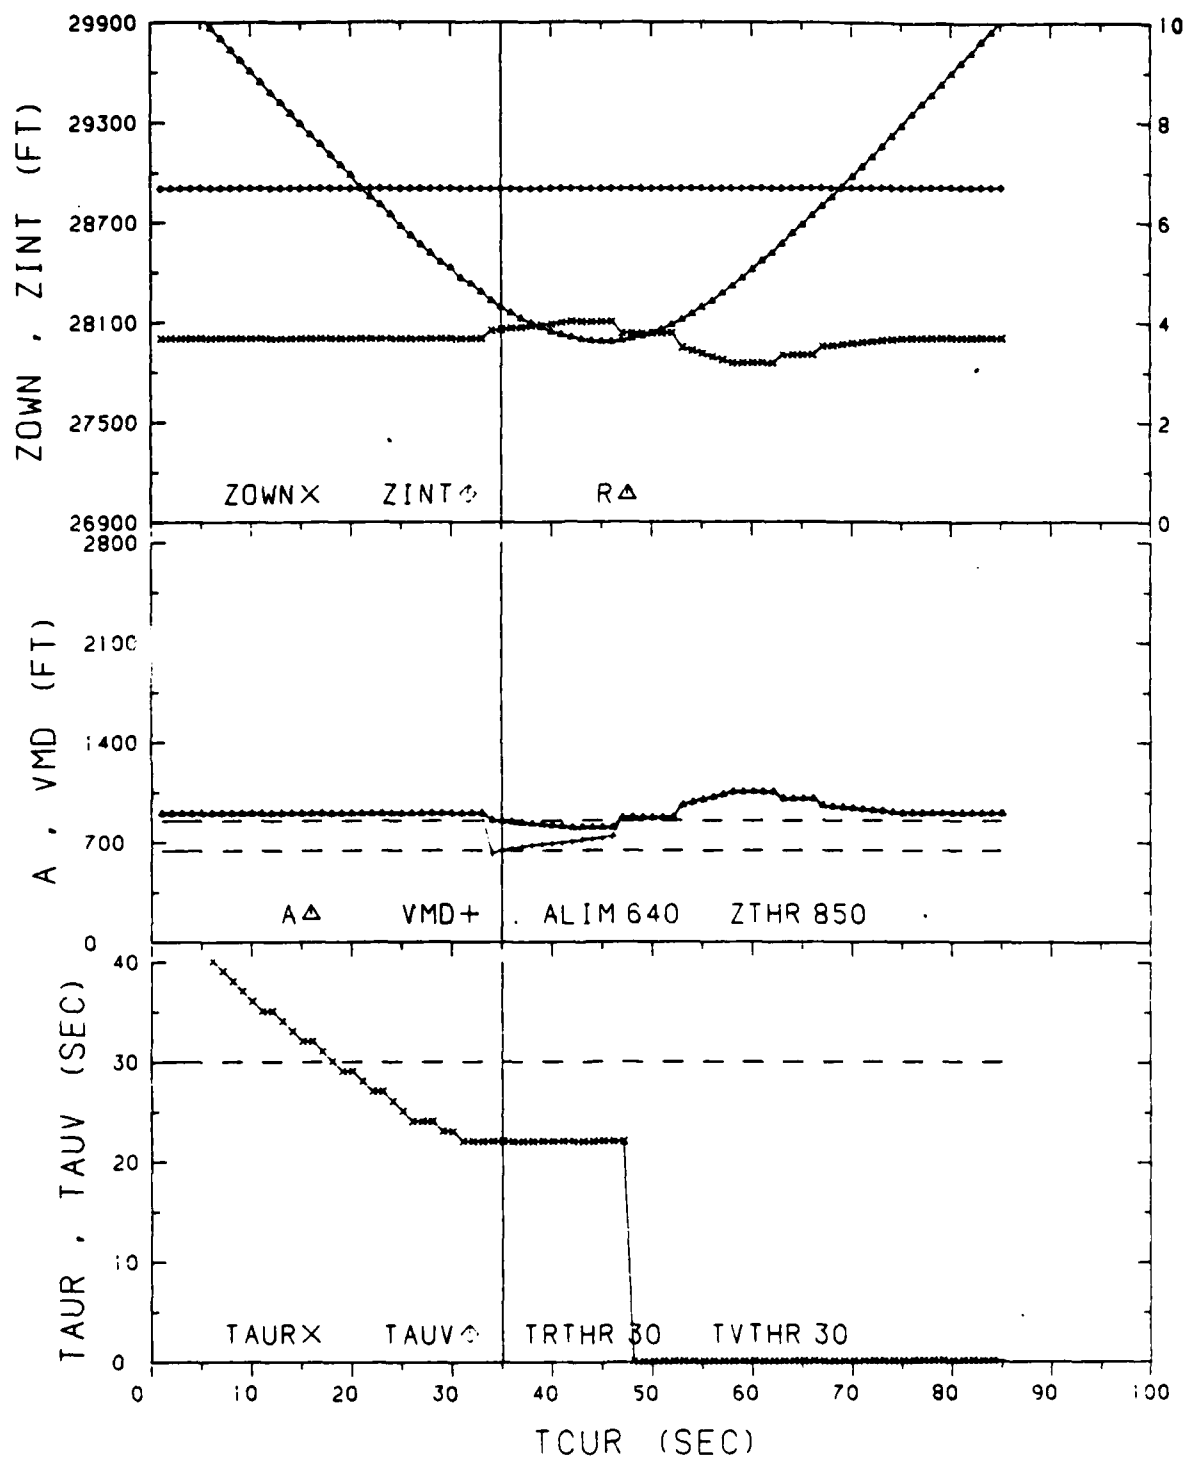
FIGURE D-26

TCAS WARNING 19: PARAMETERS

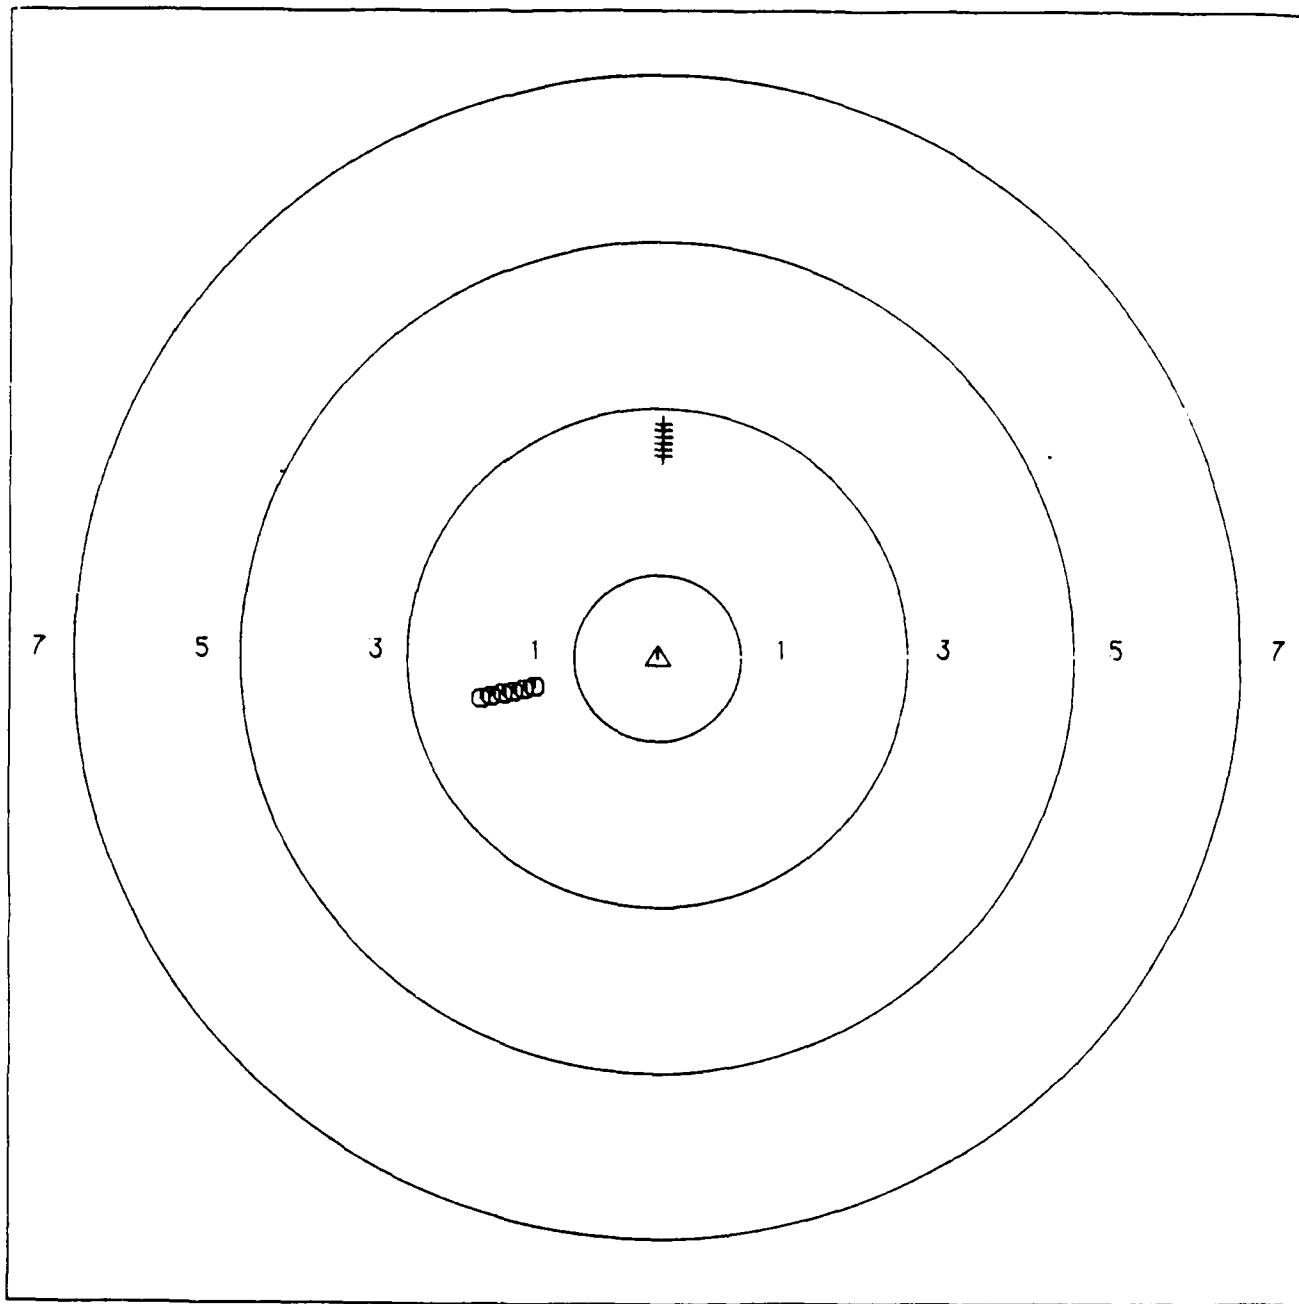
FIGURE D-45
TCAS WARNING 31: BEARING PLOT

Warning 31 occurred while there was no observer on the TCAS aircraft. The recorded data for this encounter are shown in Figures D-45 and D-46.

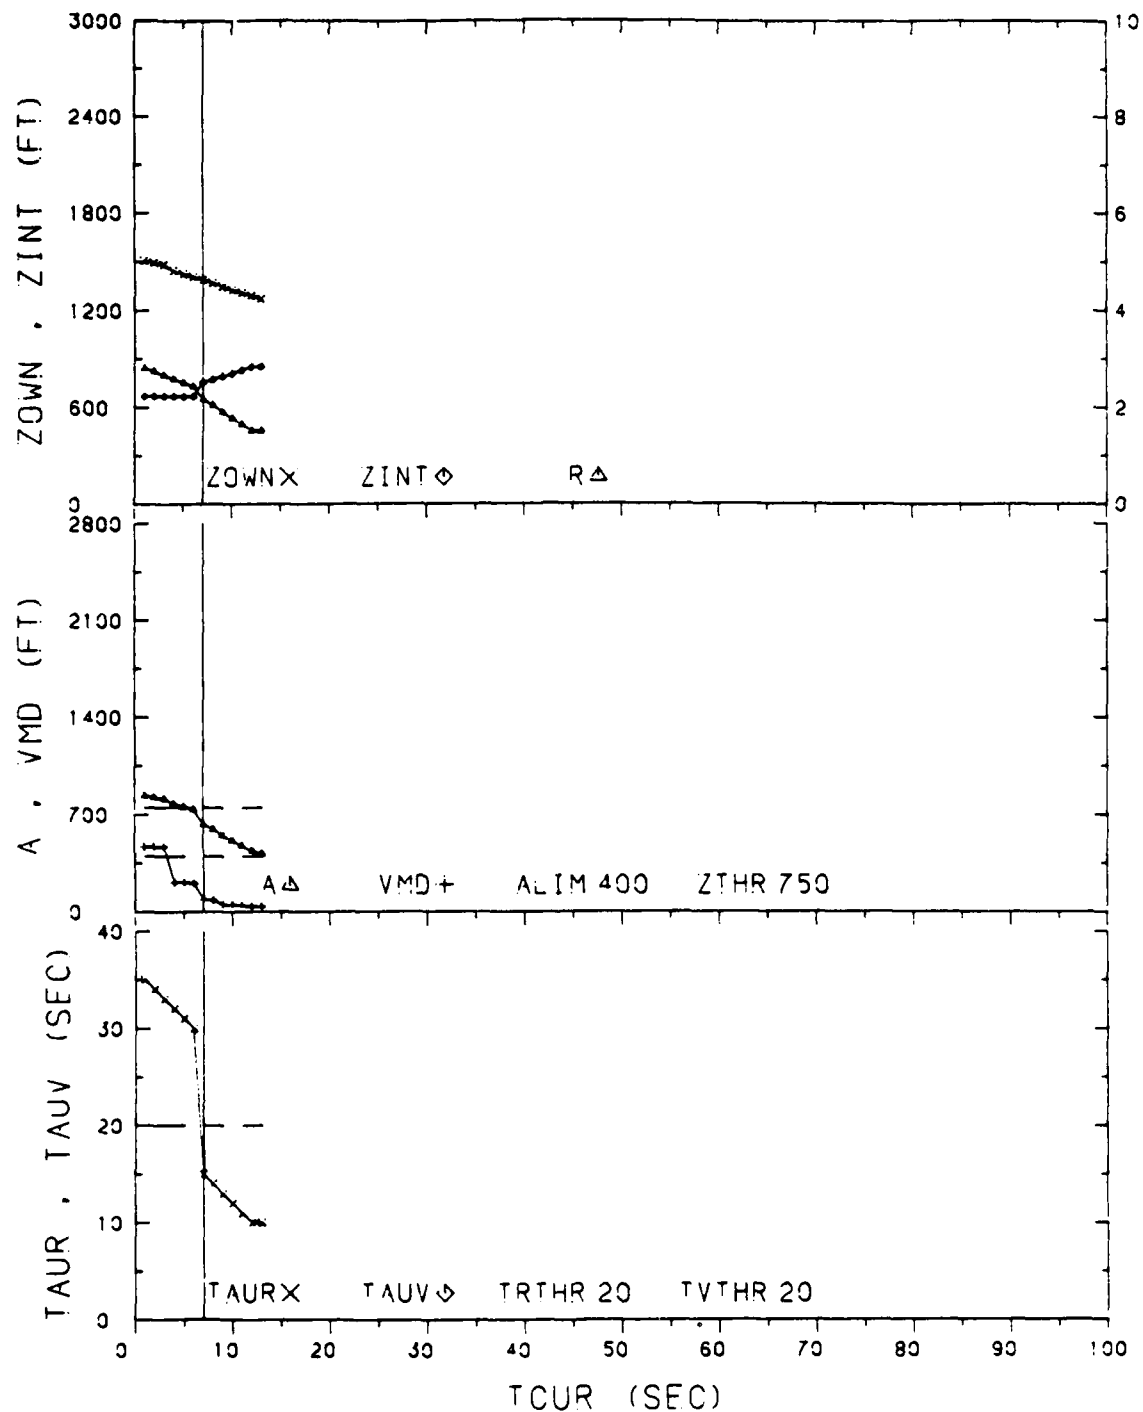
FIGURE D-46
 TCAS WARNING 31: PARAMETERS

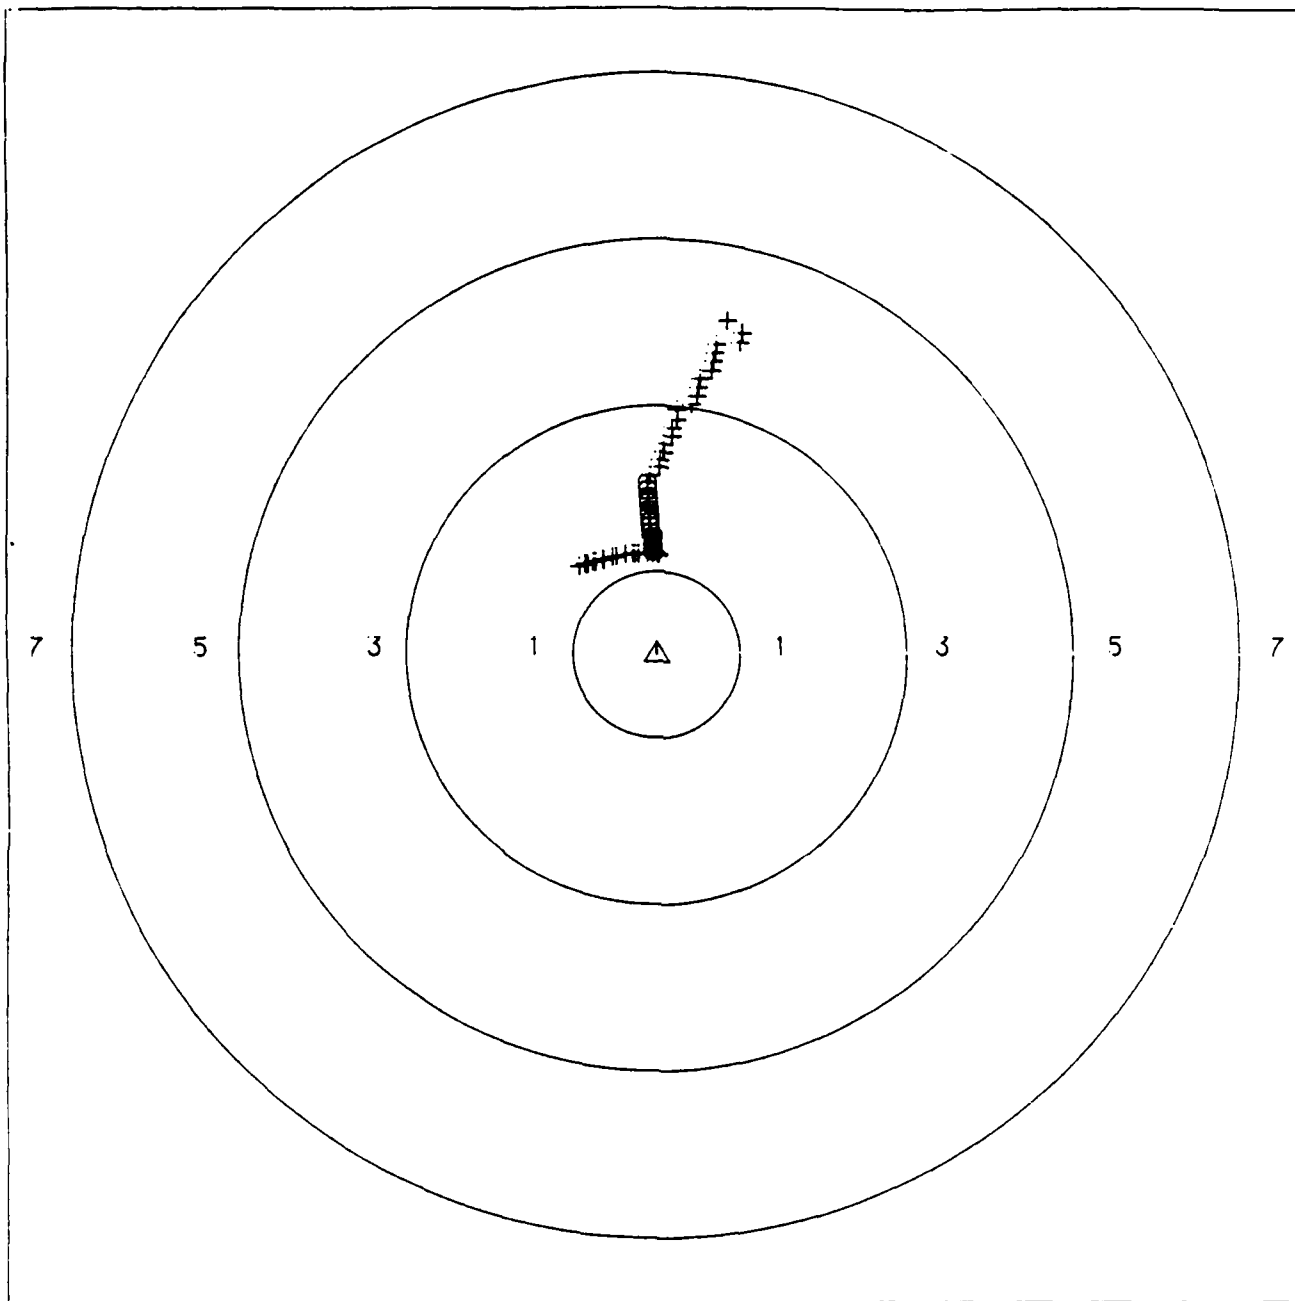
FIGURE D-47
TCAS WARNING 32: BEARING PLOT

Warning 32 occurred while there was no observer on board the TCAS aircraft. The recorded data for this encounter are shown in Figures D-47 and D-48.
